# Training Manual

## Safety Assessment Program (SAP) Evaluator

**Response and Recovery Division**

**January 2005**

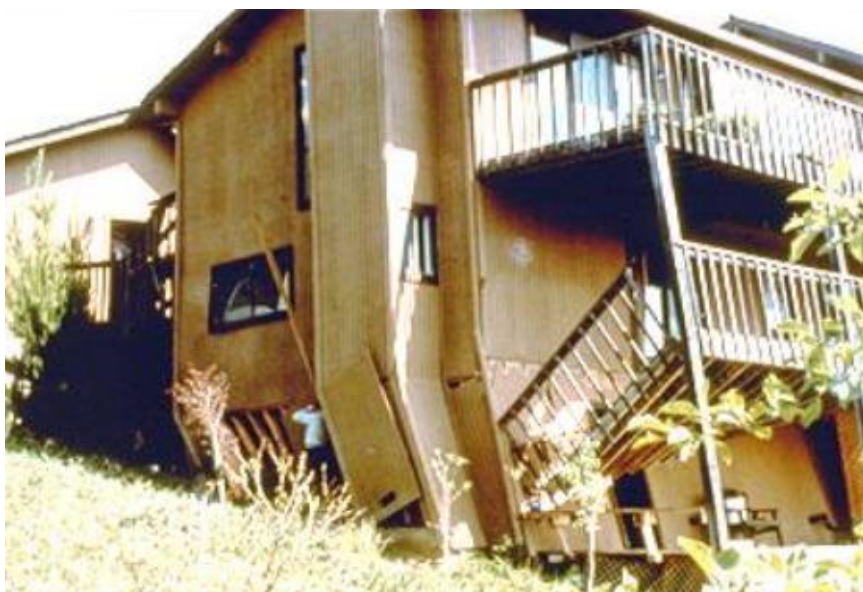
**Figure 3-30 - Home - Morgan Hill Earthquake, 1984**

The Morgan Hill earthquake seriously damaged this hillside home. As with many homes, the lowest level has the least strength due to the lack of sheathed wall length. This damage was a result, like the previous slide, of inadequate nailing of the sheathing combined with the stiffness difference between the uphill end and the downhill end. The lateral forces tend to be drawn to the stiffer end of the panel thereby overstressing the connection. This can be seen by the loss of sheathing at the uphill end of the wall.

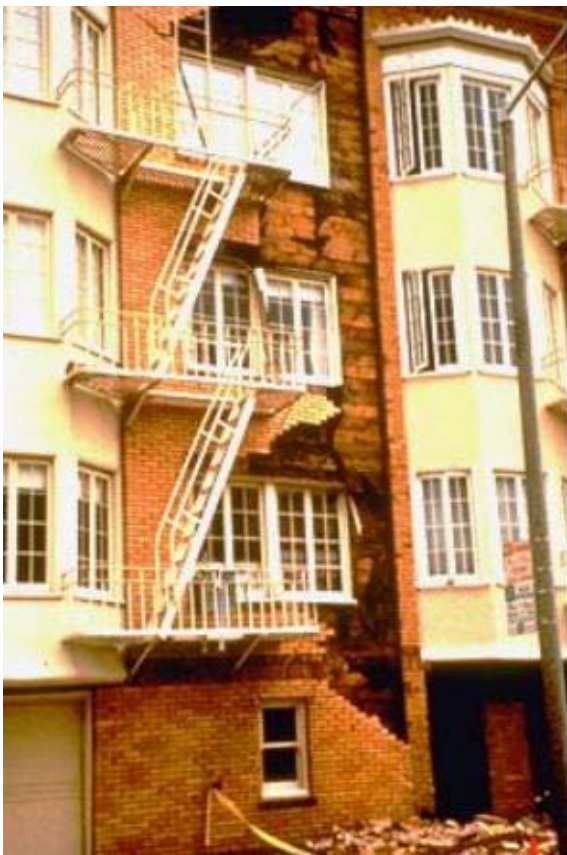
**Figure 3-31 - Apartment Building - Loma Prieta, 1989**

The Loma Prieta earthquake damaged this apartment building. In this 4-story building, the brick veneer has failed. Failure resulted from the in-plane deformation of the panel. This type of damage is typical for both thin set and full thickness brick veneer.

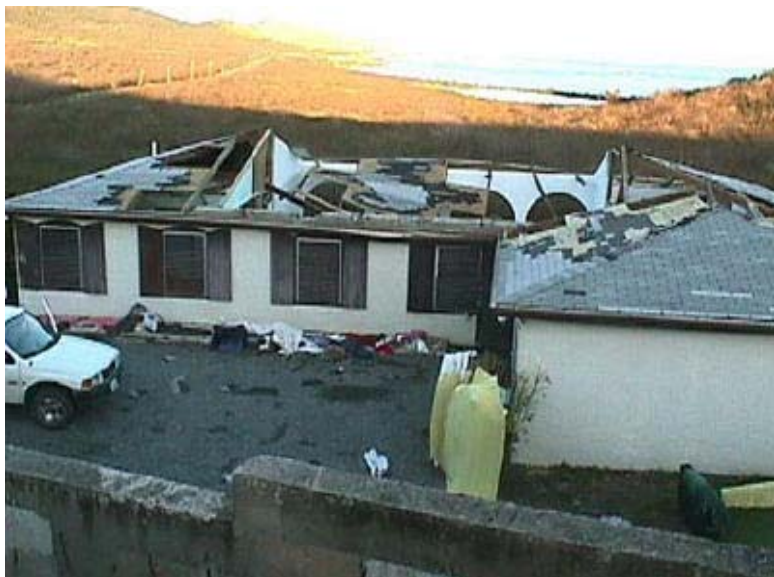
**Figure 4-1 – Virgin Islands, Hurricane Lenny, 1999**

We see that there is substantial damage to the roof. This is one of the more common forms of damage from high winds, especially in single or two-story residential structures. With the roof damaged in this manner, there is a significant amount of damage to the interior from the accompanying rains. From a safety assessment standpoint, there is significant damage to both the vertical and lateral force-resisting systems. However, since the storm is over, the likelihood of another storm occurring before the building can be stabilized or repaired is usually pretty low. This building could be posted as RESTRICTED USE to allow free access for possession retrieval and repair. Without seeing the interior we don't know if there is a falling hazard with all or portions of the ceiling. If that were in

fact the condition, then possibly portions of the home could be posted UNSAFE until the falling hazard is removed. The overall posting of the home would be RESTRICTED USE with portions UNSAFE.

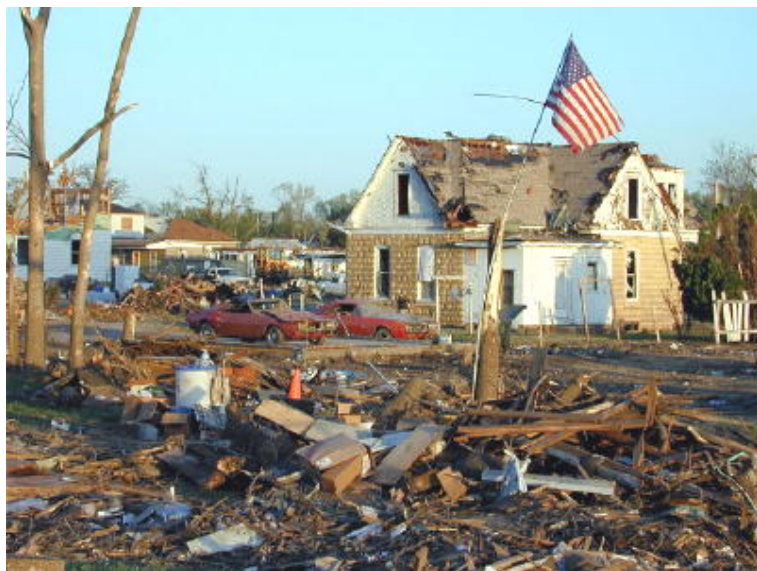
**Figure 4-3 – Kansas Tornado, 2001**

Damage from tornados can be more severe than that from hurricanes but it is usually limited to a small area. As tornados move through a community, the extreme damage is on either side of the storm and can absolutely devastate one block of homes and leave the next block with no damage at all. The safety assessment process is rather simplified as most structures will be destroyed and the entire area can be posted as AREA UNSAFE as seen in this photograph. By posting the area as UNSAFE, the jurisdiction has a means of controlling access into the area. For example, with identification showing residence or business address the property owner or tenant could have free access to look for and retrieve whatever possessions they can find.

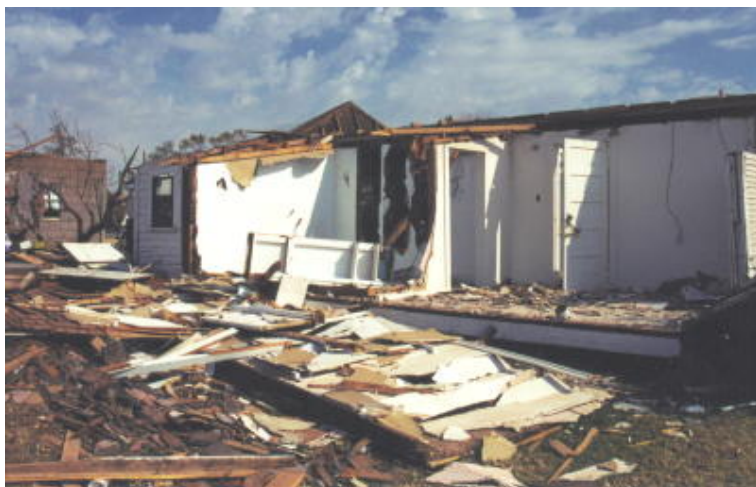
**Figure 4-4 – Kansas Tornado, 2001**

This is an example of the devastation around an area with a single structure left intact. In this case the structure was probably saved when the windows blew out because of the extreme pressure difference. This allowed the higher pressure inside the building to equalize with the surrounding area. This home most likely has a lot of content damage and broken glass (most of the glass will be outside the structure as the windows would tend to blow outward). It is possible that there could be some damage to interior walls and ceilings, leaving some falling hazards. If we assume there are no falling hazards, the home could actually be posted INSPECTED. But more realistically, it would be posted RESTRICTED USE, allowing the owner free access for

possession retrieval, but noting the potential for gas leaks and downed electrical lines. In this case, there would be an explosion and/or fire hazard that should be noted so the first ones in would turn off the gas.

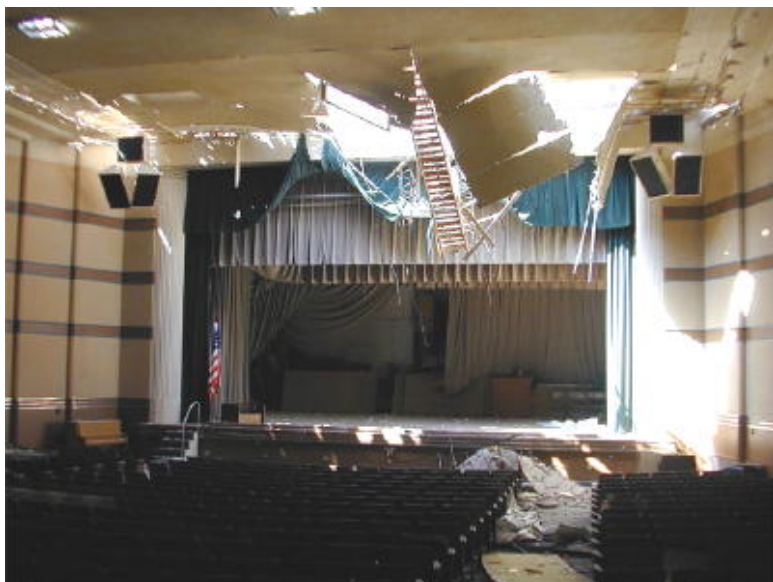
**Figure 4-5 – Cordell, Oklahoma Tornado, 2001**

This is a condition that is quite common with tornadoes and most likely would be posted as UNSAFE as there has been a partial collapse. However, one could make a reasonable argument that the structure is safe enough to allow the owners inside to retrieve possessions. In this case the structure would be posted as RESTRICTED USE for possession retrieval only.

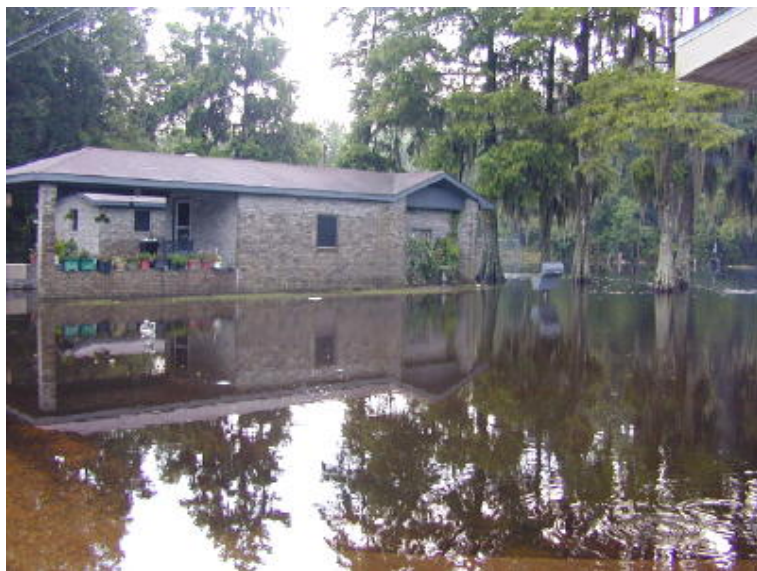
**Figure 4-7 – Louisiana, Tropical Storm Alison, 2001**

Much can be told by looking at the exterior of a structure before you enter. In this case, the water line can be seen at the top of the windows. This will tell you that the home was inundated and there will be significant content damage. From the structural standpoint, the floor framing and diaphragm will most likely have to be replaced due to warping as the materials dry out. Does this constitute reason to post the building UNSAFE? No, that is a condition of repair. In most cases, homes subjected to a slow moving flood will be posted as INSPECTED or possibly RESTRICTED USE. If ceiling materials have been soaked, they do represent a potential falling hazard. This would be sufficient to cause a RESTRICTED USE posting with a caution that ceilings have been soaked and could fall.

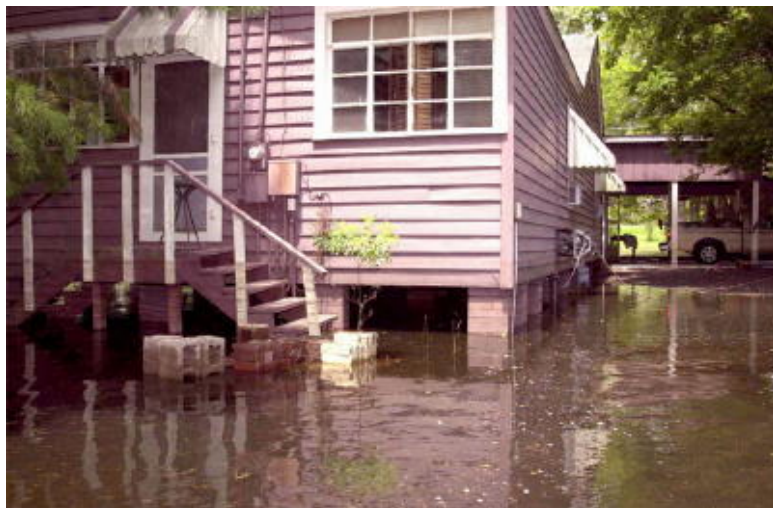
**Figure 4-8 – Louisiana, Tropical Storm Alison, 2001**

In this case, the structure has been raised and portions of the foundation wall have been left open to allow for airflow during non-flood conditions, and to allow the water to flow through when flooded. Looking at the picture, we see that the water level did not reach the first floor level. Therefore, evaluation of this property would be primarily around the foundations to ensure that all are sound; there has been no settlement; and no scouring around the corners of the foundation walls. This building could be posted as INSPECTED. You would also look for the high water mark to determine if the framing could have been soaked. Again, wet framing is not grounds for a RESTRICTED USE or UNSAFE posting. However, a comment

about potential warping of the framing in the Comments box on the placard and evaluation form would be appropriate.

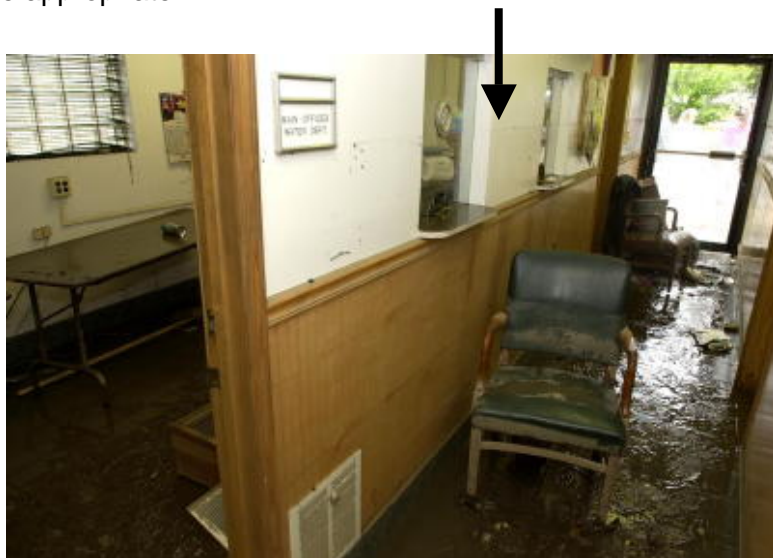
**Figure 4-9 – West Virginia Flood, 2001**

This picture is a good example of the lack of structural damage as a result of slow moving floods. The arrow shows the water line at the time of maximum flood depth. Certainly the finishes will need to be repaired by either cleaning or replacing as necessary, and there is a significant amount of mud and debris on the floor. In this case, the floor is a concrete slab on grade; so warping does not present a problem as it dries out. The water line was above electrical outlets and air duct outlets. This building should be posted RESTRICTED USE and possession retrieval allowed. The posting should not be changed to INSPECTED until adequate cleanup and repair of wetted surfaces, wiring and equipment has been done.

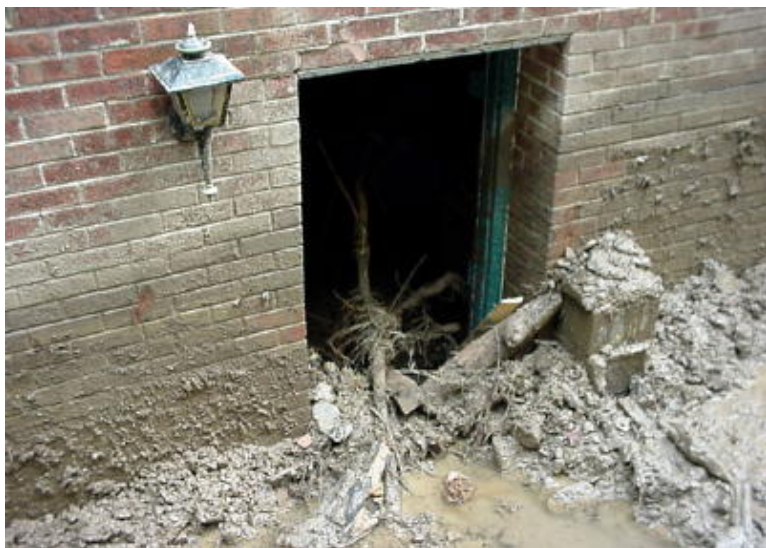
(Photograph courtesy of FEMA)  
**Figure 4-10 – West Virginia Flood, 2001**

Another hazard that accompanies floods and must be considered in a safety evaluation is mud and debris that can block openings, denying access to buildings. In this picture, we see mud and debris covering approximately half the door height. This type of debris build-up precludes access to the building from a strictly practical standpoint. Once the debris is removed, access is fully available. If evaluations were performed prior to the debris removal, the most likely posting for this structure would be **RESTRICTED USE**, with no access until debris is removed.

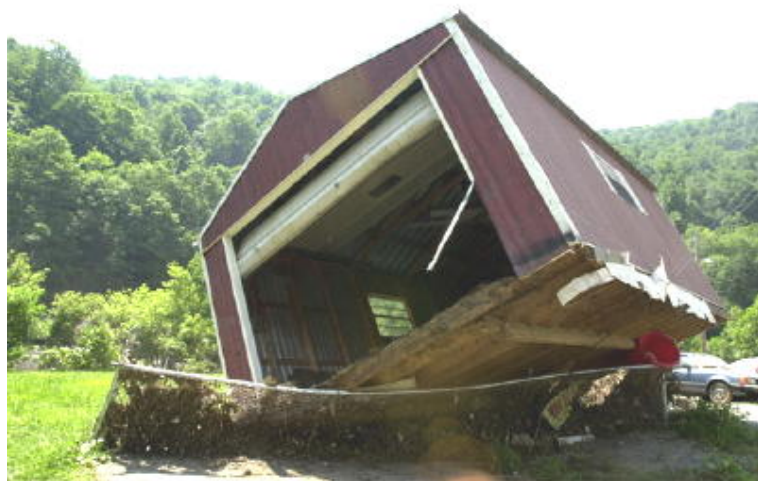
(Photograph courtesy of FEMA)  
**Figure 4-11 – West Virginia Flood, 2001**

In this picture, we see a garage that most likely did not have a foundation and was just sitting on the ground. As the floodwaters struck the building, it floated and was deposited downstream onto this fence. This building should be posted **UNSAFE**, as it is a collapse hazard. The difficulty in filling out the evaluation form and the placard is trying to ascertain the address. This is not uncommon with outbuildings. The best that can be done is to describe the building and where it was found, with the hope that local officials can eventually identify who it belongs to.

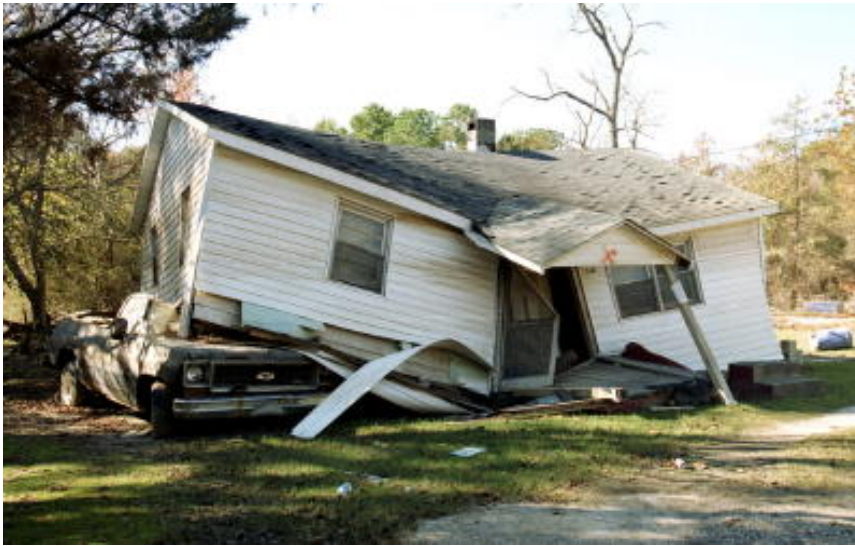
(Photograph courtesy of FEMA)  
**Figure 4-12 – Hurricane Floyd, North Carolina**

Even structures that are connected to their foundations will not always withstand the pressure of fast moving water. These structures are moved off their foundation and move with the water until they come to rest, are destroyed by the flow, or the water level drops, depositing them in some unknown location. In this case, the home was deposited on top of a vehicle. However, vehicles will be swept away much faster than buildings, so we don't know if this vehicle belongs with the structure. For safety evaluation there is no doubt that this would be posted as UNSAFE. Again, the problem

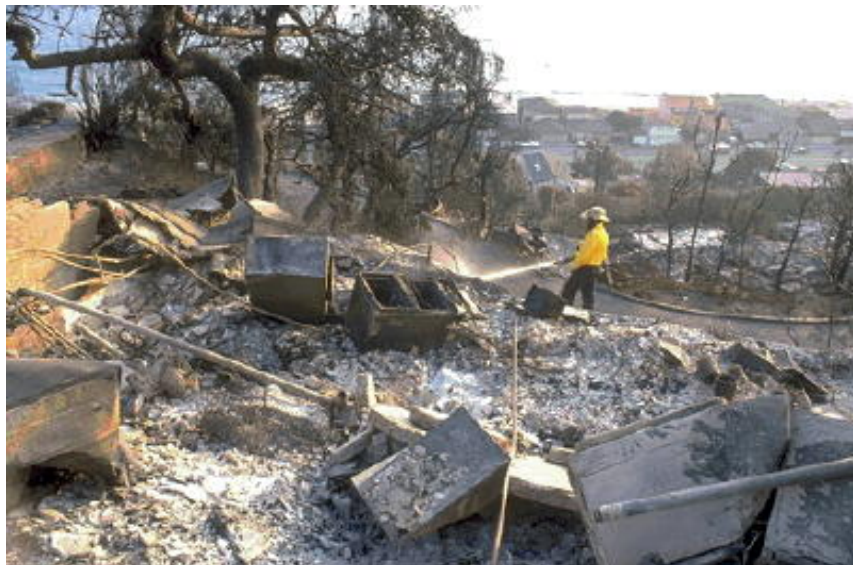
(Photograph by Robert A. Eplett, California OES)  
**Figure 4-13 – Southern California Fire Storms 1993, Malibu**

As can be seen in this picture, entire neighborhoods were burned to the ground. With the hot debris lying on the slabs, there is a question regarding the potential for re-using these foundations. Should the Safety Assessment Program be activated for this type of evaluation, the determinations would not be final. If the evaluations showed that foundations potentially could be re-used, the homeowner would need to retain an engineer to fully evaluate the footings for heat damage before the foundation could be re-used.

The extreme heat generated by urban-wildland fires can cause serious damage to the concrete or masonry in the footings. The expansion of the material from the heat can cause serious cracking and spalling. However, if firefighters were on scene when the structure began to burn and were able to keep the surrounding area cool, there is a possibility that the foundation may be able to be re-used.

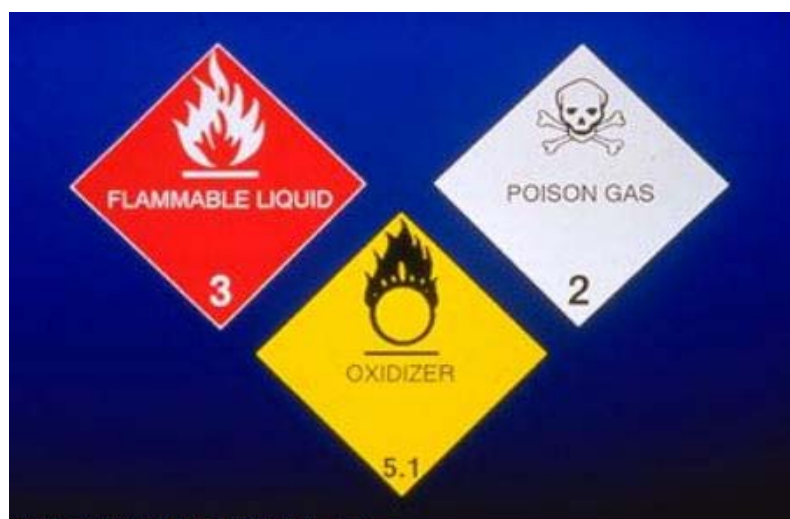
**Figure 5-3 - Examples of DoT Placards**

This figure provides some examples of the placards used in the DoT system. Additionally, containers with materials that have multiple classifications would have a placard for each classification. As with the building placards, remember that these placards indicate what is supposed to be in the container. Just because a placard indicates some rather benign materials, you cannot guarantee that the container actually contains that particular material.

The DoT system is primarily used for labeling containers of hazardous materials that are transported. The placards are classified by hazard class names, hazard class numbers, associated color, identifying pictographs and an identification number. Figure 5-2 on page 5-9 outlines these categories and Figure 5-3, also on page 5-9 is an example of the placard. The pictographs are commonly used symbols for various hazards; for example, flames indicate fire hazard, a skull and crossbones indicates poisonous material. The identification number on the placards indicates the primary hazard class of the hazardous material contained.

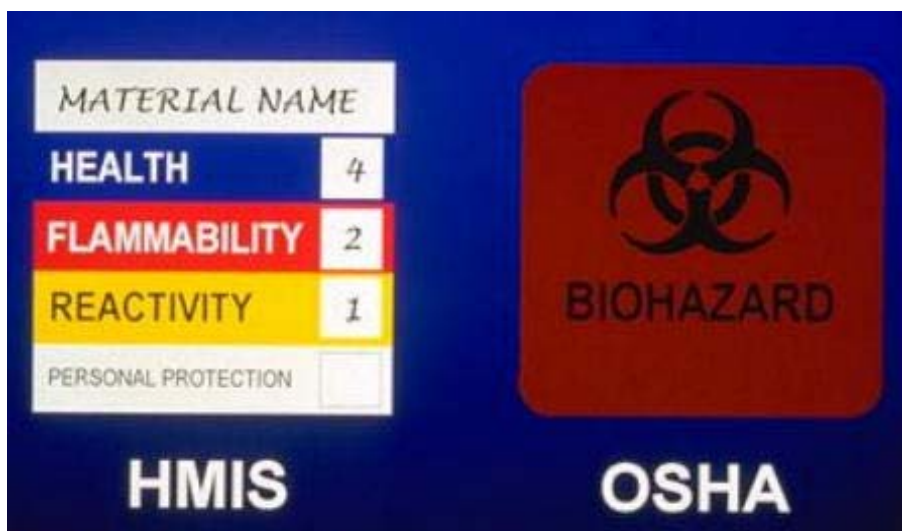
Figure 5-4 – National Paint and Coatings Association HMIS and OSHA Placards

The National Paint and Coatings Association has developed a Hazardous Materials Information System (HMIS) for employers to use to comply with the California hazard communication system. The labels are divided into four: health, flammability, reactivity, and personal protection. Figure 5-4 on the following page shows what the placard looks like and includes OSHA's designation for a potentially infectious material.
